INDOOR AIR QUALITY ASSESSMENT

**Sherwood Middle School
30 Sherwood Avenue
Shrewsbury, Massachusetts 01545**

Prepared by:
Massachusetts Department of Public Health
Center for Environmental Health
Emergency Response/Indoor Air Quality Program
January 2006

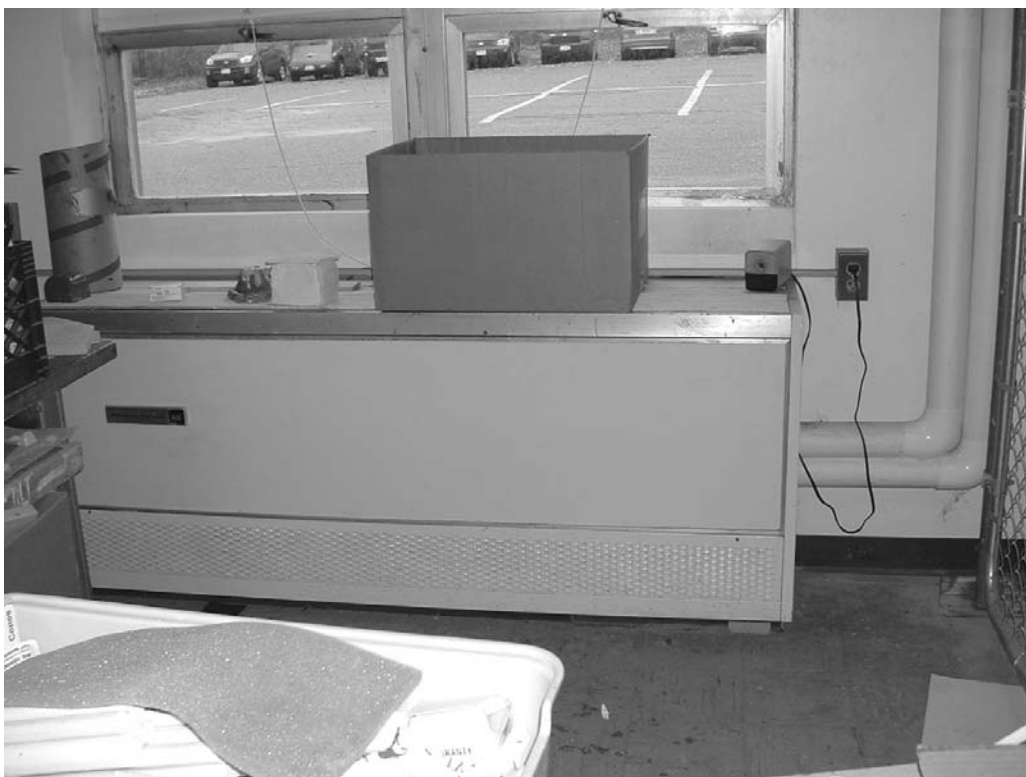
Picture 1

Fresh air in classrooms is supplied by a unit ventilator (univent) system (Picture 1) installed with high efficiency pleated air filters. A univent is designed to draw air from outdoors through a fresh air intake located on the exterior wall of the building and

return air through an air intake located at the base of the unit ([Figure 1](#)). Fresh and return air are mixed and filtered, then heated and provided to classrooms through an air diffuser located in the top of the unit. Univents are reportedly original equipment, over 40 years old. Univents of this age can be difficult to maintain because replacement parts are often unavailable. Univents were operating in all areas surveyed during the assessment. However, obstructions to airflow, such as papers and books stored on univents and bookcases, carts and desks in front of univent returns, were seen in several classrooms. In order for univents to provide fresh air as designed, univent air diffusers and return vents (located along the front of units) must remain free of obstructions.

Classroom Univent, Note Box, Pencil Sharpener and Other Items on Unit

1. Examine each univent for function. Survey classrooms for univent function to ascertain if an adequate air supply exists for each room. Consider consulting a heating, ventilation and air conditioning (HVAC) engineer concerning the calibration of univent fresh air control dampers throughout the school.

2. Operate all ventilation systems that are operable throughout the building continuously during periods of school occupancy and independent of thermostat control. To increase airflow in classrooms, set univent controls to “high”.

3. Inspect exhaust motors and belts for proper function. Continue with plans to repair and replace as necessary.
4. Remove all blockages from univents and exhaust vents to ensure adequate airflow.

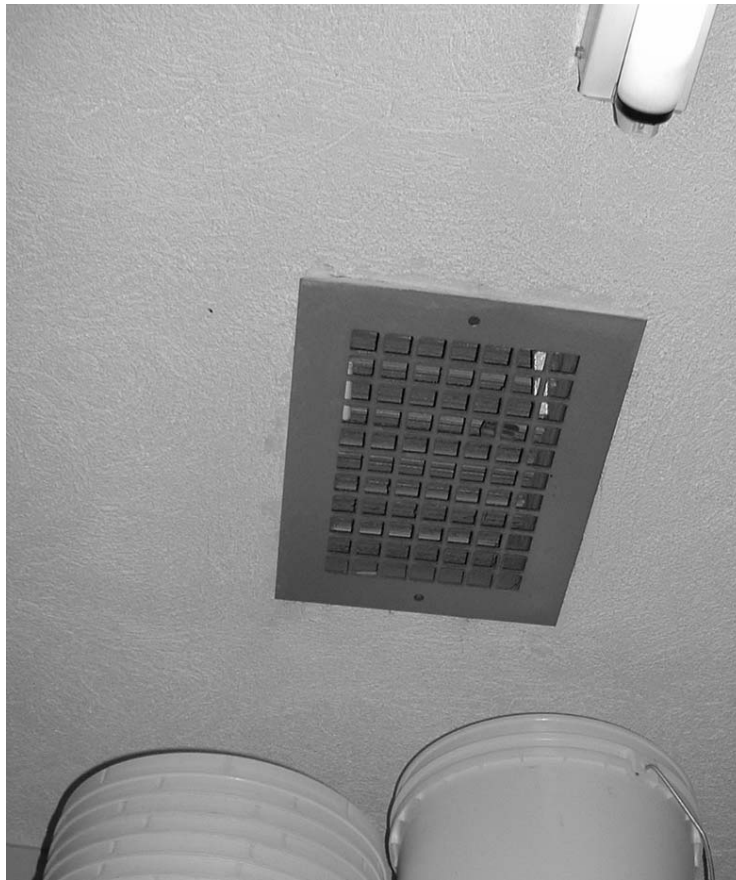
Picture 3

Exhaust ventilation in classrooms is provided by ducted, grated wall or ceiling vents (Pictures 2 and 3) powered by rooftop motors. Several rooftop exhaust vents were on order to be repaired; therefore, no means of mechanical exhaust for these classrooms was being provided during the assessment. A number of exhaust vents were also obstructed by desks, bookcases and other items (Picture 2). As with the univents, in order to function properly, exhaust vents must be activated and remain free of obstructions. In addition, the location of some exhaust vents can limit exhaust efficiency. In several rooms, exhaust vents are located near hallway doors. When these classroom doors are open exhaust vents become blocked (Picture 4). Exhaust vents in these rooms will also tend to draw air from both the hallway and the classroom, reducing the effectiveness of the exhaust vent to remove common environmental pollutants.

Ceiling-Mounted Exhaust Vent in Science Classroom

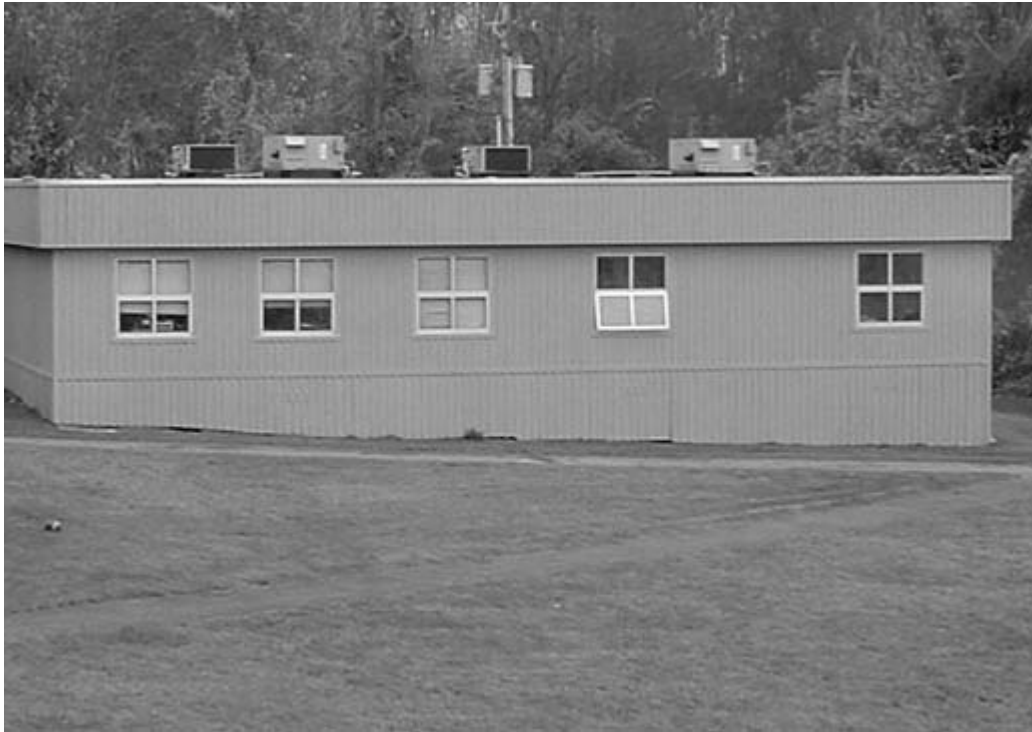
Picture 5

Ventilation for modular classrooms is provided by AHUs (Picture 5). Fresh air is distributed to classrooms via ductwork connected to ceiling-mounted air diffusers (Picture 6) and drawn back to the AHUs through return grilles. Thermostats control each

Rooftop AHUs for Modular Classrooms

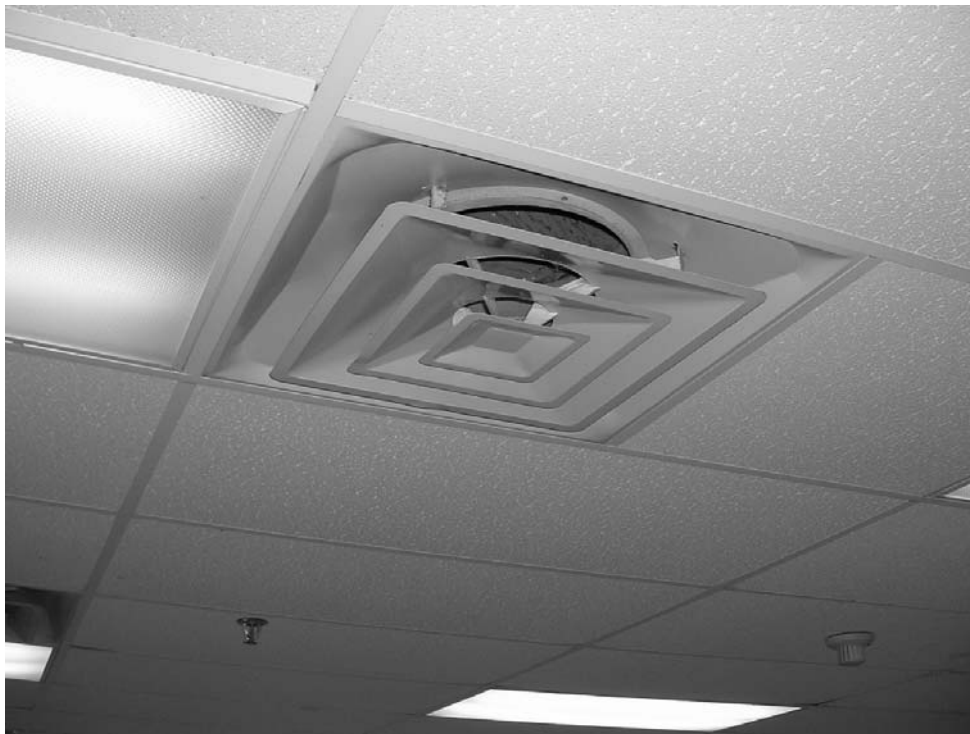
Picture 6

Ceiling-Mounted Vent in Modular Classroom, Note Both Supply and Return Use Similar Vents

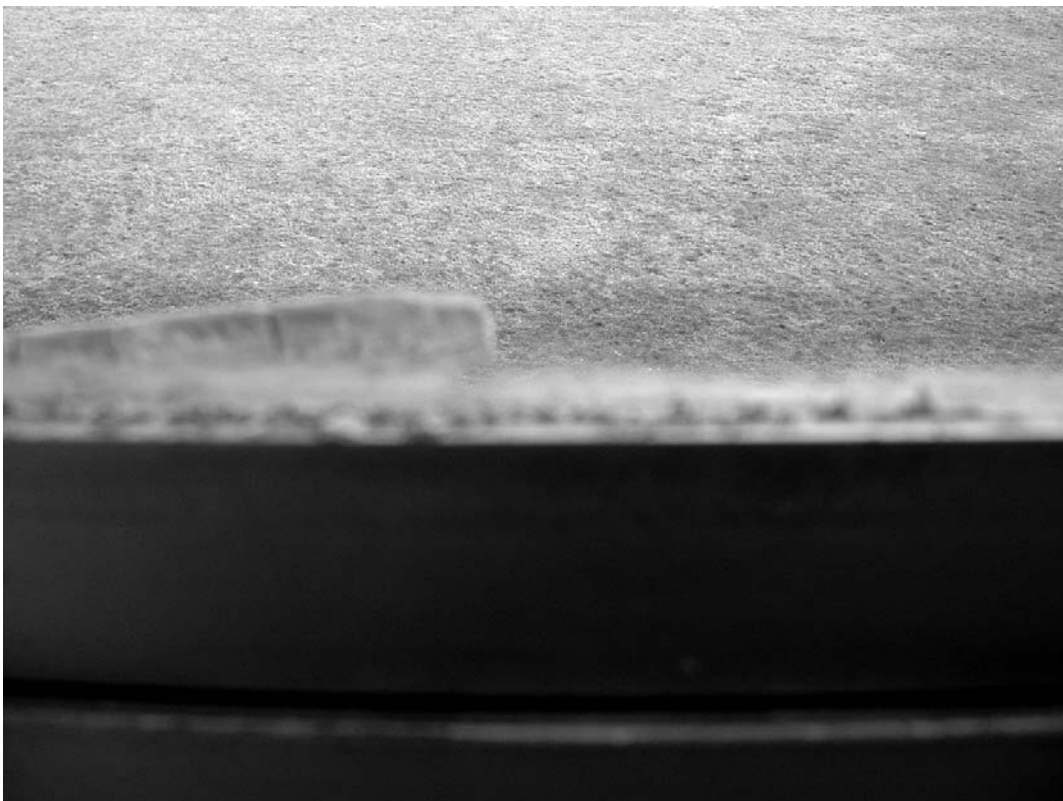
Picture 8

Several potential pathways for moisture to enter the building were identified, most notably around window frames (Picture 8). Historic water damage as evidenced by peeling paint, crumbling plaster and efflorescence was observed throughout the building (Pictures 9 to 11). Efflorescence is a characteristic sign of water damage to brick and mortar, but it is not mold growth. As moisture penetrates and works its way through mortar and brick, water-soluble compounds in mortar and brick dissolve, creating a solution. As the solution moves to the surface of the mortar or brick, the water evaporates, leaving behind white, powdery mineral deposits. Replacement of caulking and repairs of window leaks are necessary to prevent water penetration and subsequent damage to building materials, which can lead to mold growth and associated odors.

Missing/Damaged Window Caulking

1. Replace/repair window systems throughout the building-wide to prevent water penetration and drafts through window frames. Consider having exterior brick re-pointed and waterproofed to prevent water intrusion. Weatherproofing materials should be applied during periods when the school is not occupied.
2. Contact an HVAC engineering firm for an assessment of the ventilation system’s control system (e.g., controls, air intake louvers, thermostats). Based on the age, physical deterioration and availability of parts for ventilation components, such an evaluation is necessary to determine the operability and feasibility of repairing/replacing the equipment.

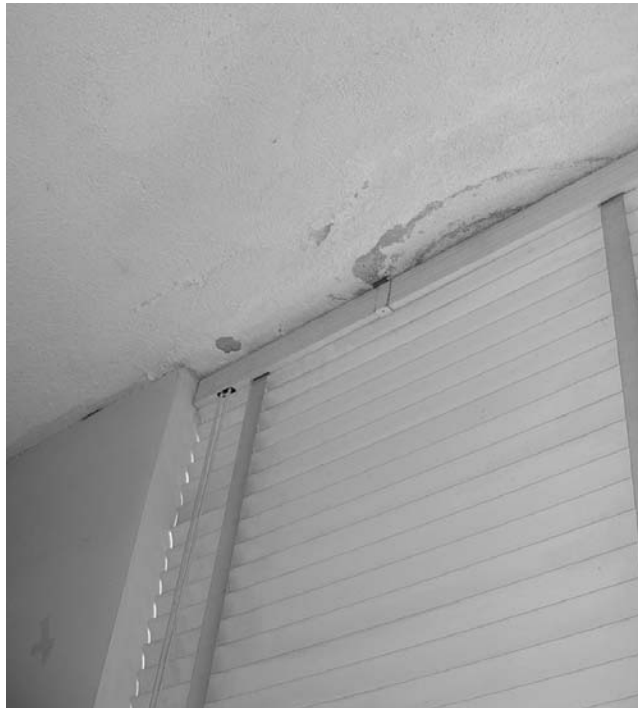
Picture 9

Water Damaged Ceiling Plaster above Window Frames

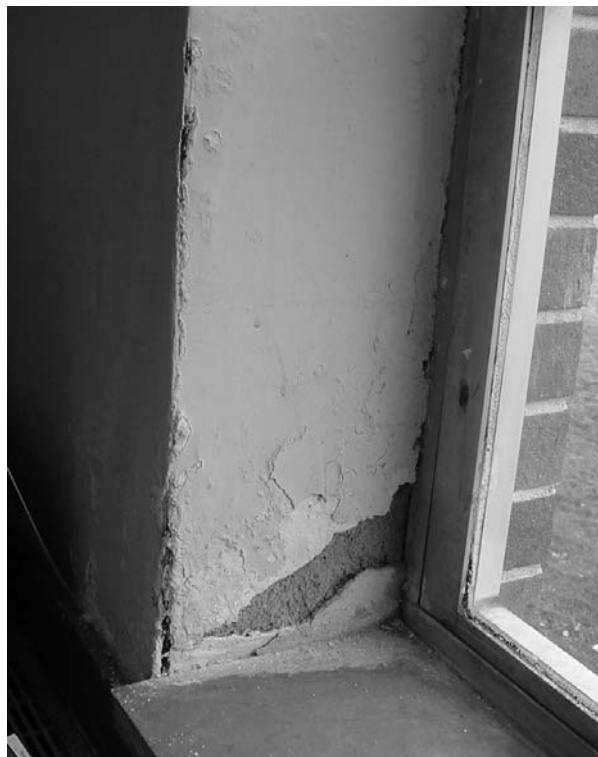
Picture 10

Water Damaged Wall Plaster near Window Frames

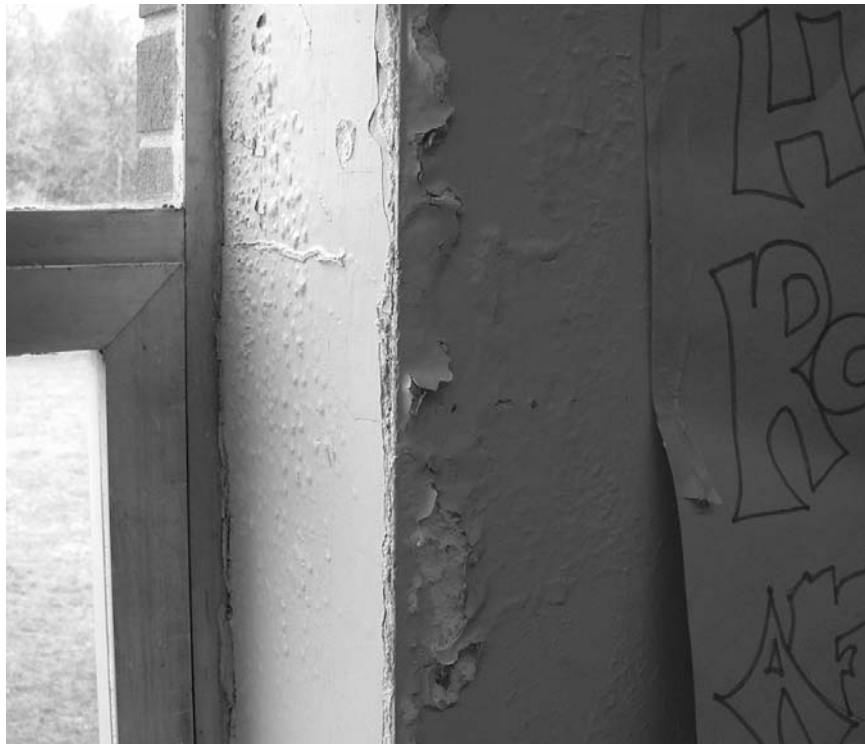
Picture 11

Water Damaged Wall Plaster near Window Frames

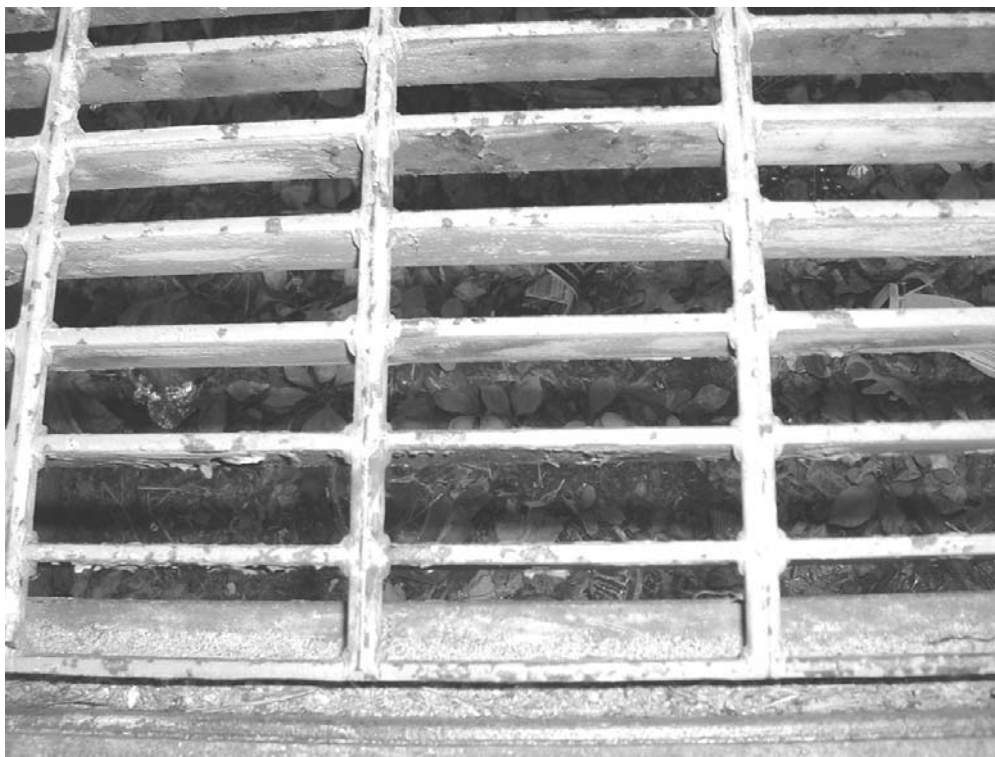
Picture 12

Several subterranean pits were located along the perimeter of the building. These pits allow air to flow below grade into air intakes for the mechanical ventilation system. Leaves, papers and other debris were observed on the floor of these pits (Picture 12). Such debris can provide a source of mold growth.

Plant Growth and Debris in Subterranean Pit

12. Remove leaves and debris from subterranean pits seasonally.
13. Vacuum interior of univents during regular filter changes to prevent the accumulation/aerosolization of dirt, dust and particulates.

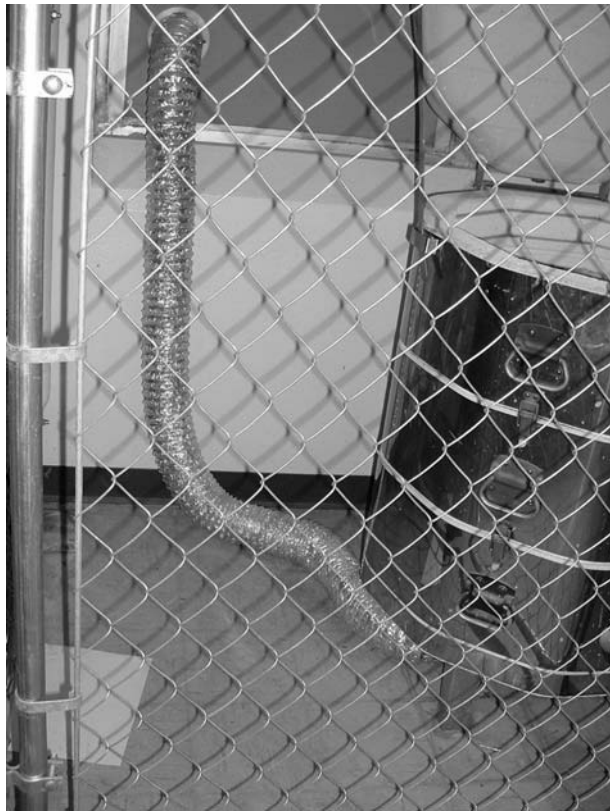
Picture 13

The art room contains a kiln that is ducted out of the building in the general vicinity of a univent air intake (Pictures 13 and 14). Because the kiln exhaust vent empties downward *towards* the air intake, the possibility of re-entrainment of kiln exhaust is possible depending on certain wind and weather conditions.

Kiln in Art Room Vented to the Outside

17. Remove or remediate damaged floor tiles in conformance with Massachusetts asbestos remediation and hazardous waste disposal laws.
18. Consider relocating or extending local exhaust vent for kiln to prevent the entrainment of exhaust into the univent air intake for the art room.

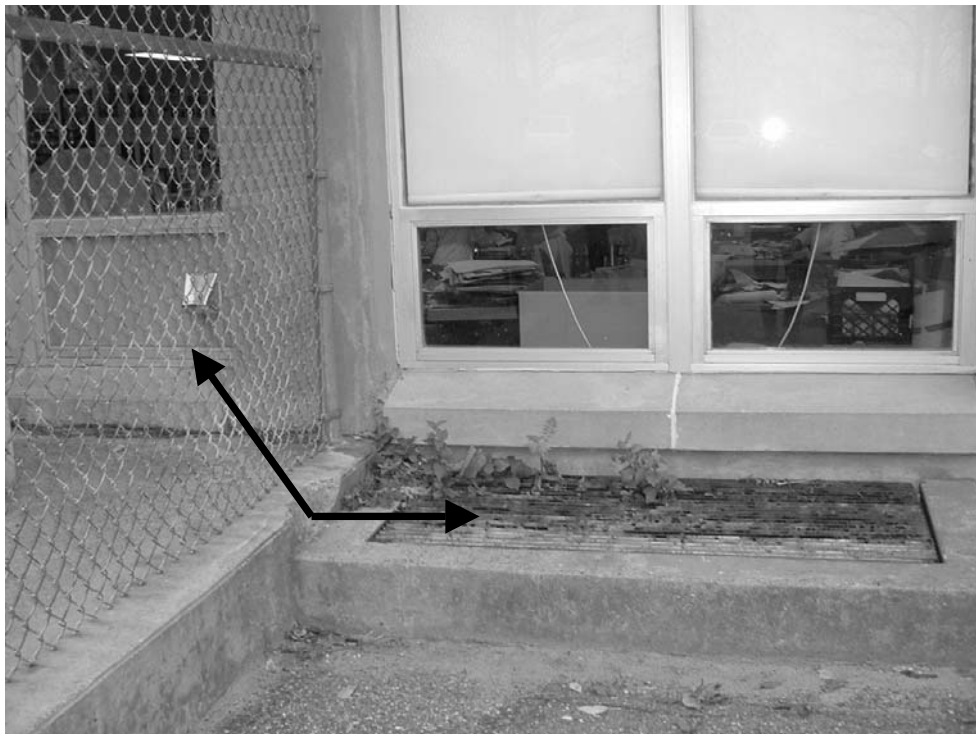
Picture 14

Exterior View of Kiln Exhaust and Univent Air Intake

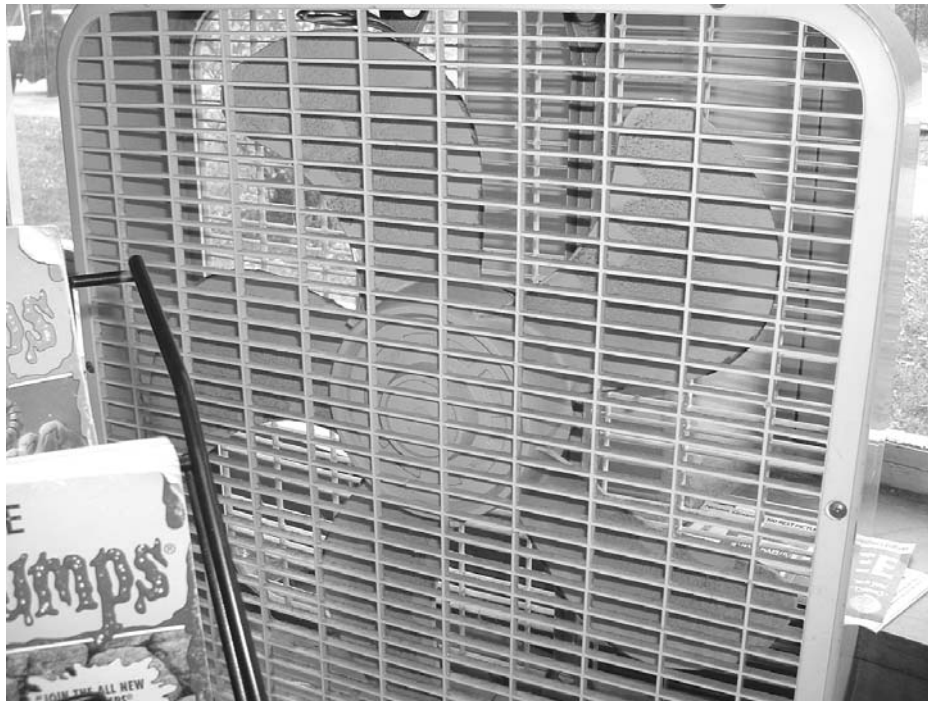
Picture 15

In some classrooms, items were observed on windowsills, tabletops, counters, bookcases and desks. The large number of items stored in classrooms provides a source for dusts to accumulate. These items (e.g., papers, folders, boxes) make it difficult for custodial staff to clean. Items should be relocated and/or be cleaned periodically to avoid excessive dust build up. Accumulated dust was observed on the blades of personal fans and on exhaust vents in several classrooms (Pictures 15 and 16). If exhaust vents are not functioning, backdrafting can occur, which can re-aerosolize accumulated dust particles. The fan blades should be vacuumed periodically to prevent aerosolization when fans are activated. Dust can be irritating to eyes, nose and respiratory tract.

Dust Accumulation on Fan Blades

14. Clean accumulated dust from blades of personal fans and exhaust vents on a regular basis.
15. Relocate or consider reducing the amount of materials stored in classrooms to allow for more thorough cleaning. Clean items regularly with a wet cloth or sponge to prevent excessive dust build-up.

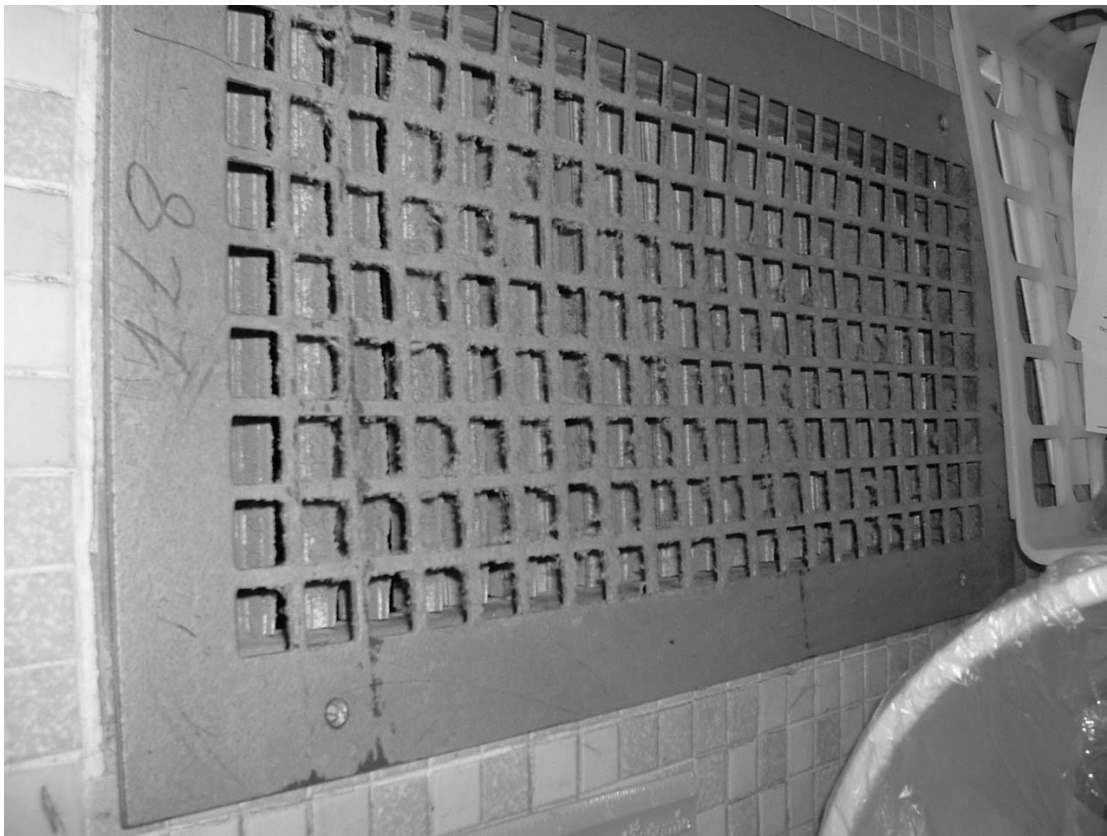
Picture 16

Dust Accumulation on Exhaust Grill

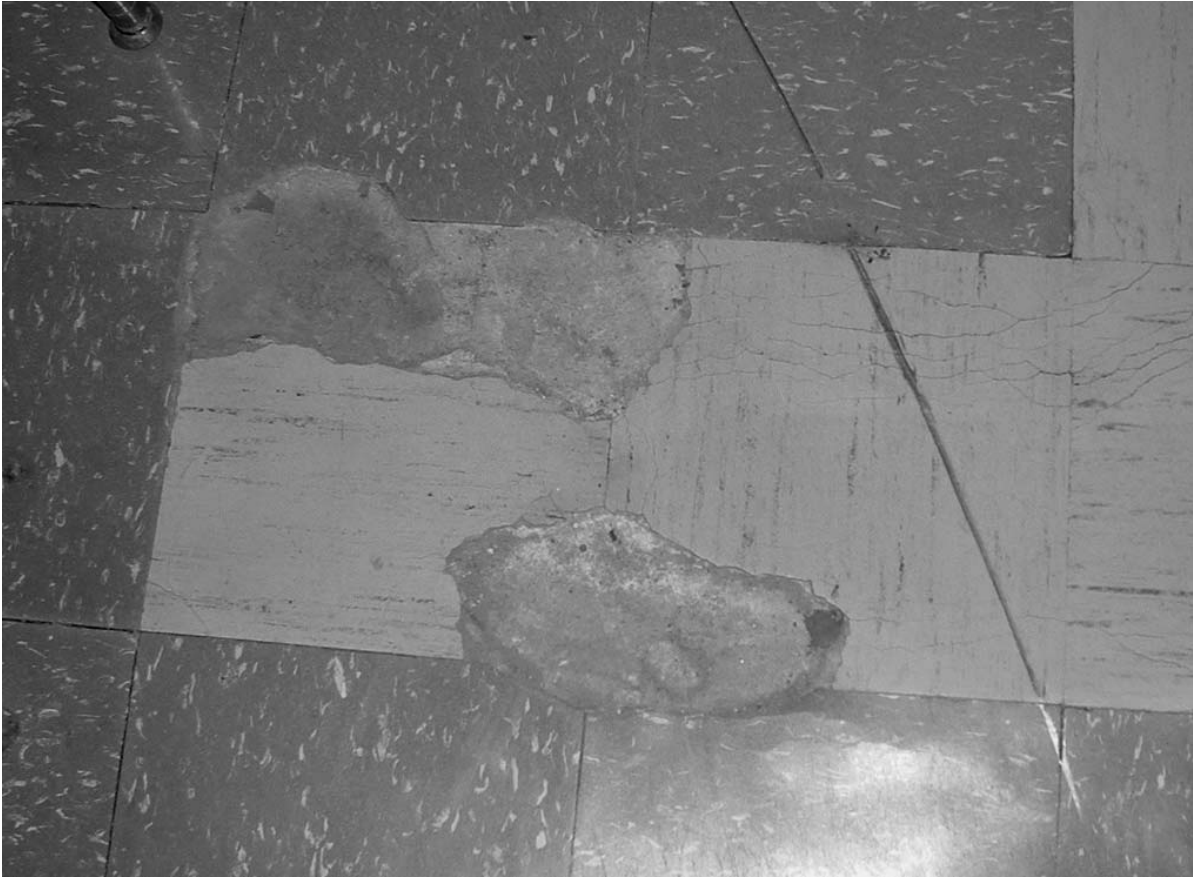
Picture 17

Finally, occupants expressed concerns regarding the condition of floor tiles in the hallway outside of classroom 121 (Picture 17). Floor tiles of this type and age often contain asbestos. Intact asbestos-containing materials (ACM) do not pose a health hazard. If damaged, ACM can be rendered friable and become aerosolized. Considering that tiles are predominately in the hallways, materials from broken tiles are more likely to

be aerosolized in there high traffic areas. Friable asbestos is a chronic (long-term) health hazard, but will not produce acute (short-term) health effects (e.g., respiratory symptoms, headaches) typically associated with buildings perceived to have indoor air quality problems. Where ACM are found damaged, these materials should be removed or remediated in a manner consistent with Massachusetts asbestos remediation laws (MDLI, 1993).

Damaged Hallway Floor Tiles near Classroom 121
